Memorandum

Date: 21 November 2010
To: Tamara Zeier, P.E., Project Navigator
Copies to: Ken Fredianelli, Geosyntec Consultants
From: Neven Matasovic, Ph.D., P.E., G.E., Geosyntec Consultants
Alan Witthoeft, E.I.T., Geosyntec Consultants
Subject: **Stability Evaluation
Berm Between Lagoons 2 and 3
Ascon Landfill, Huntington Beach, California**

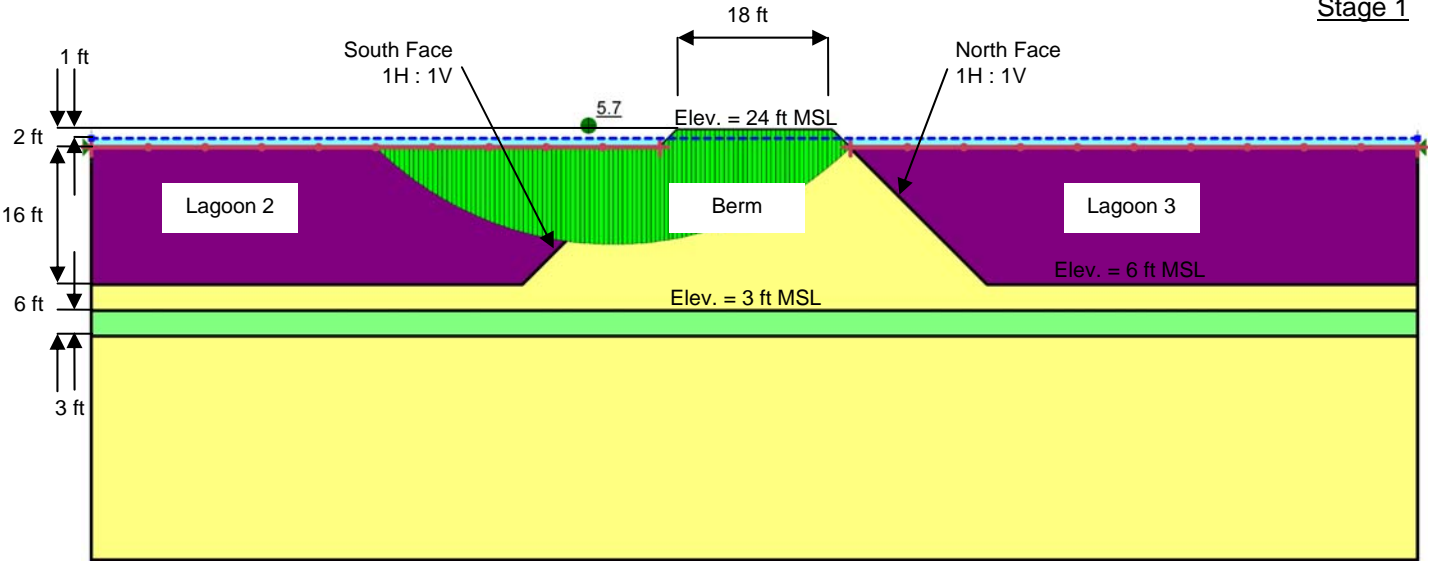
Stage 1

The stability evaluations were conducted in stages that roughly mimic completed and proposed construction sequencing. The first stage, schematically shown in the top part of Figure 2, represents the condition of the Berm prior to lagoon material removal. As the Berm is buttressed by lagoon material from both sides, there are no stability concerns. The results of the formal stability analysis, also shown in top part of Figure

2, indicate failure in a so-called bearing capacity mode, with calculated Factor of Safety, FS, of 5.7.

Pre-existing Conditions (FS = 5.7)

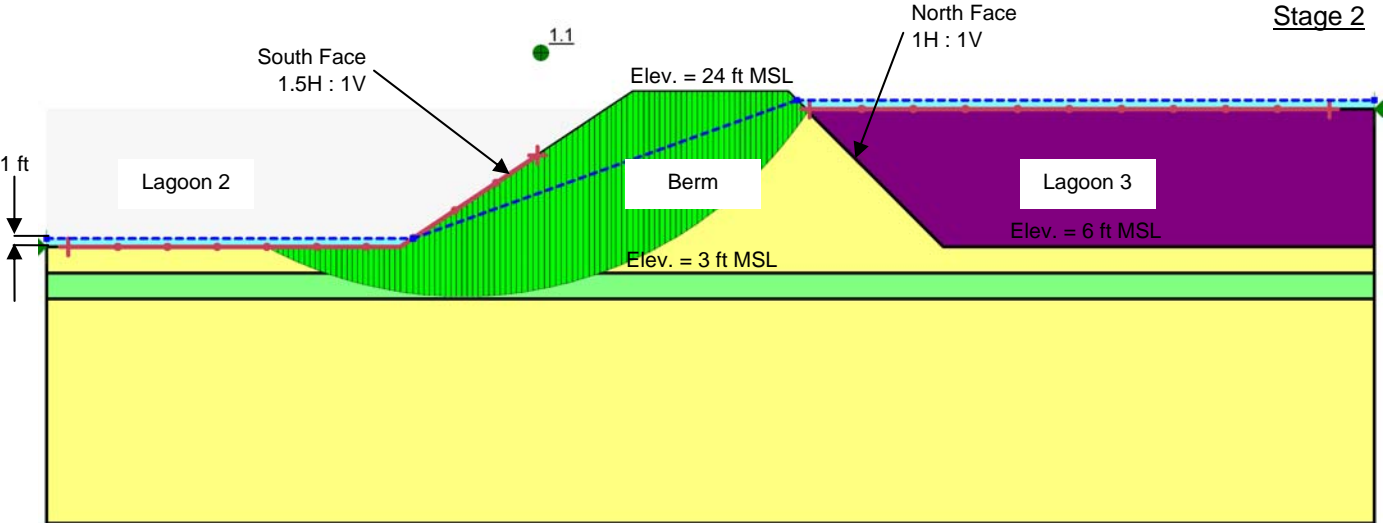
Stage 2

The second stage represents the Berm's condition upon removal of material from Lagoon 2. As shown in the bottom part of Figure 2, for this condition, calculated FS is 1.1. As FS greater than or equal to 1.3 is typically considered acceptable for temporary slopes, remedial measures against slope failure are required.

Removal of material from Lagoon 2 resulted in a potentially unstable slope condition. The calculated Factor of Safety (FS) of Southern Face of the berm between Lagoons 2 and 3 (Berm) is on the order of 1.1, approximately 15 percent lower than a typically accepted value of 1.3 for this type of slope.

South Face Exposed (FS = 1.1)

The results of our evaluations indicate that the stability of Berm can be increased by either removal of material from Lagoon 3 or by construction of a buttress at the toe of South Face. However, given the difficulties associated with construction of such a buttress at a toe of potentially unstable slope (health and safety concerns associated with construction/vibration at the toe of potentially unstable slope, difficulty to achieve required soil compaction when compacting over a soft Lagoon 2 floor subgrade, and long-term settlement of the buttress), we recommend removal of material from Lagoon 3 as the most viable option.

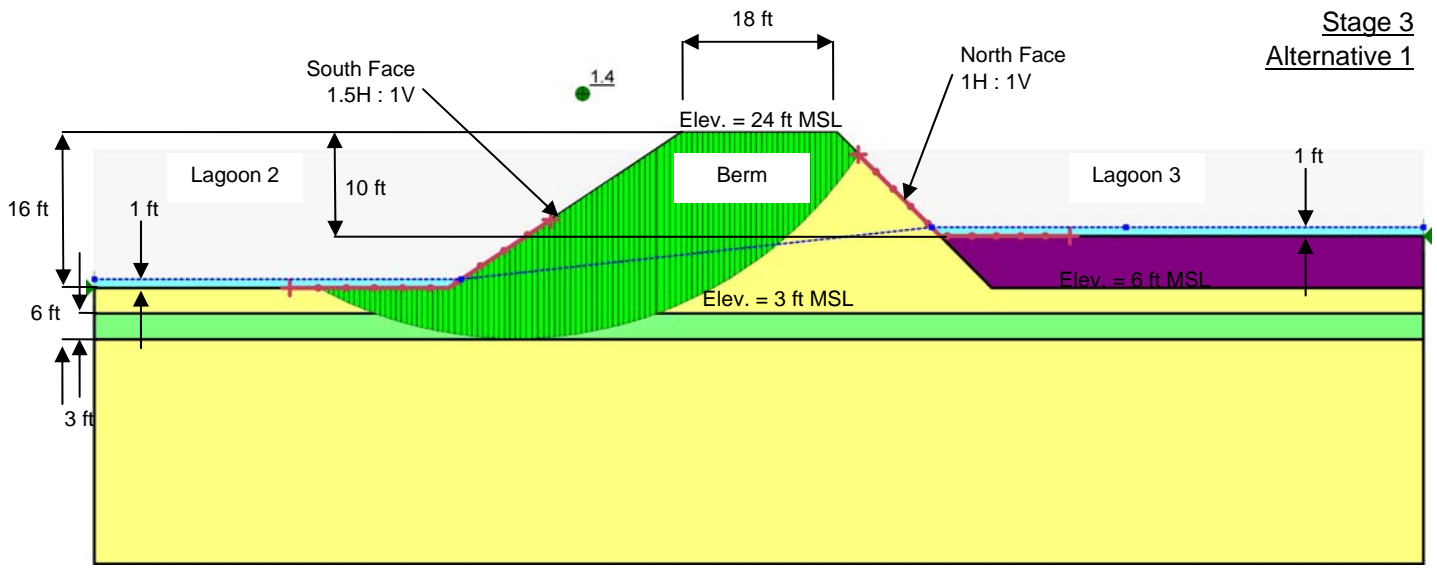
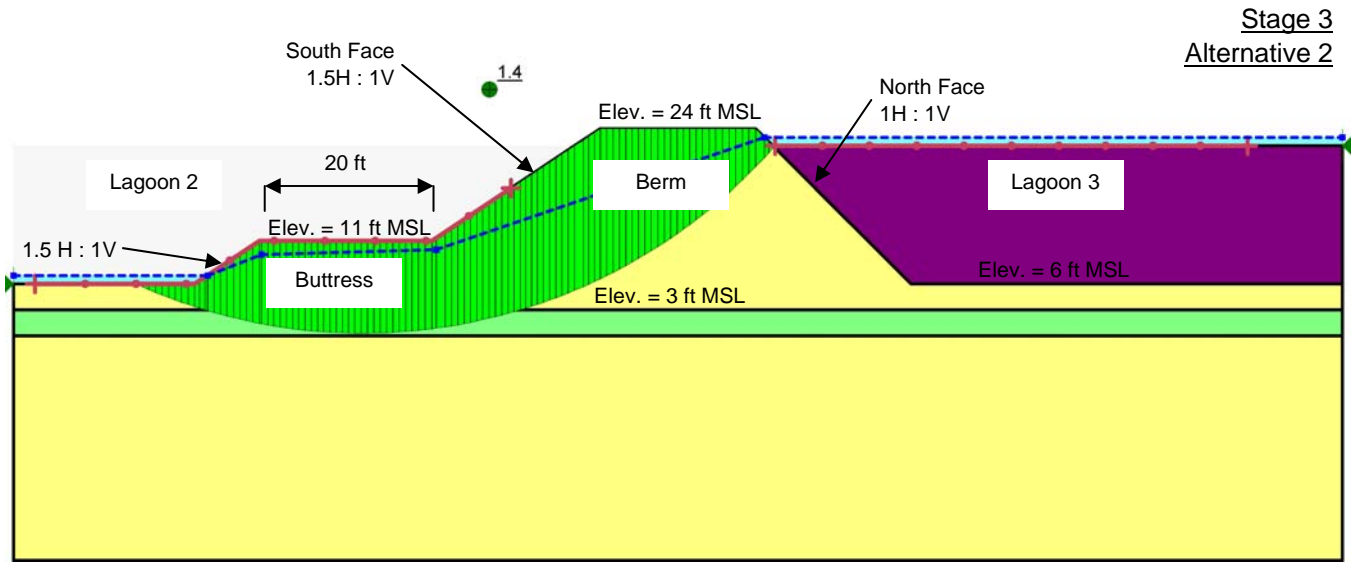
The third stage consists of two alternatives to increase stability the Berm. The first alternative is to remove material from Lagoon 3. Up to approximately 10 ft of material needs to be removed from Lagoon 3 to achieve FS greater than 1.3. The second alternative is to construct a buttress along the South Face. The results of this evaluation indicate that an approximately 20-ft wide, 5-ft tall soil buttress is required to achieve the same effect as removal of 10 ft of Lagoon 3 material.

North Face Partially Exposed (FS = 1.4)

North Face Partially Exposed and South Face Butressed (FS = 1.4)

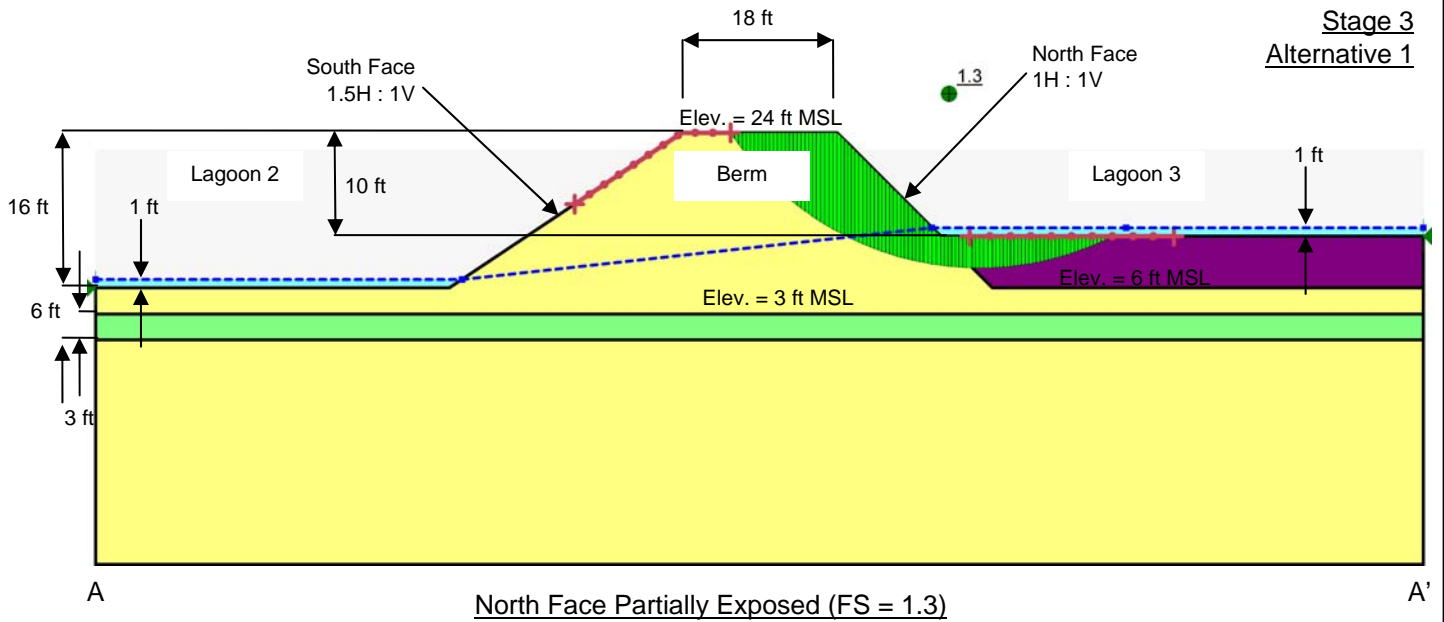
DATE: NOVEMBER 2010	FILE NO.
PROJECT NO. HG1131-01J	FIGURE NO. 4

Figure 4 presents a supplemental analysis performed in order to assess the impact of excavation from Lagoon 3 on the stability of the North Face. As indicated in the figure, calculations show a FS of 1.3 after excavation of material from Lagoon 3. This suggests that the North Face of the berm will not be adversely affected by the proposed excavation.
