TIDAL INFLUENCE STUDY LETTER REPORT DATED JULY 7, 2003, AND TIDAL INFLUENCE STUDY DATA

July 7, 2003

RE: Tidal Study and Well Gauging Results
Ascon Landfill Site
Huntington Beach, California

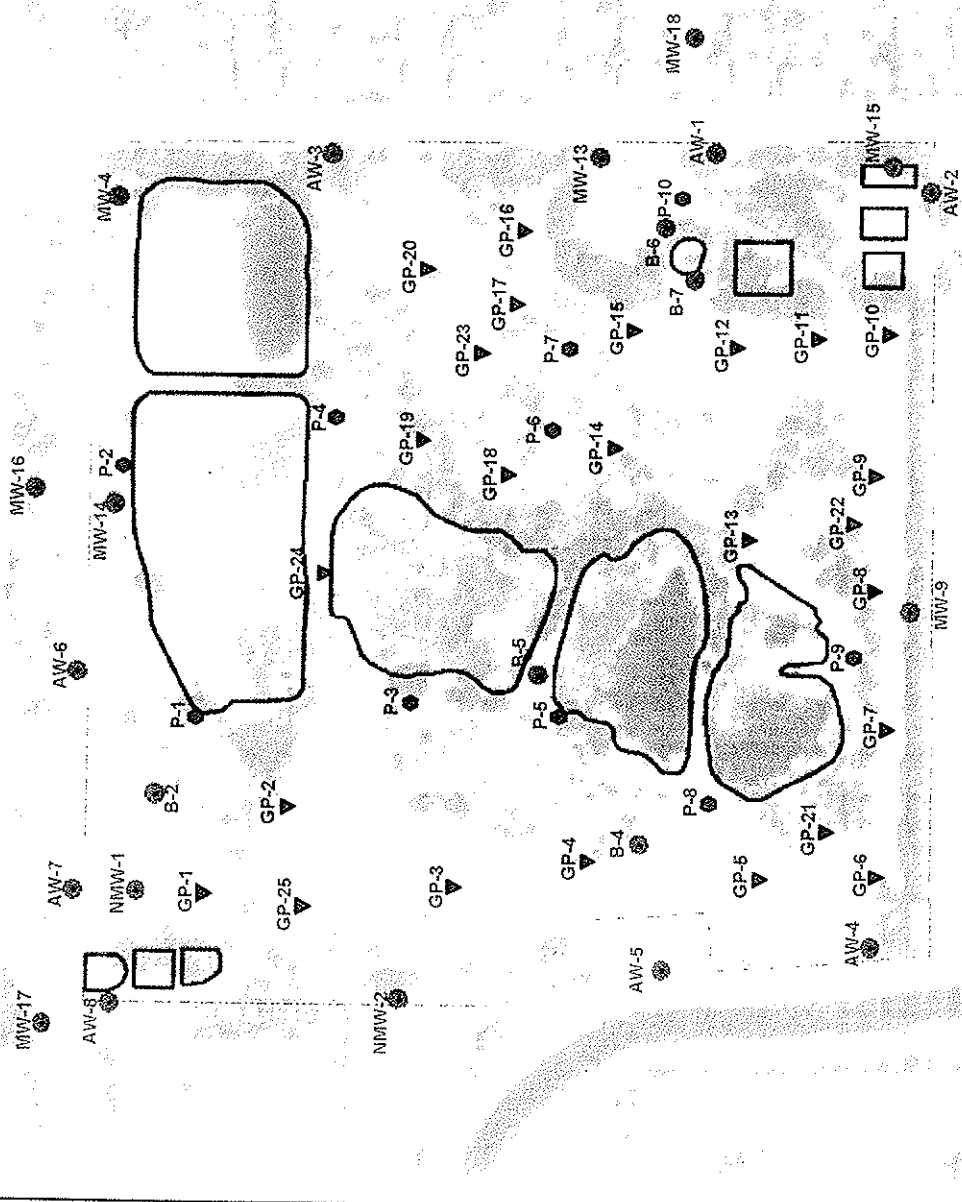
Well and Piezometer Location Map

- NOTES:**
1. Monitoring wells AW-6 and AW-7 have been reported as being paved over during the expansion of Hamilton Avenue in 1986 (ESE, 1997).
 2. GP-18 casing damaged at surface.
 3. Monitoring well AW-1 and geoprobe monitoring location GP-19 could not be located.

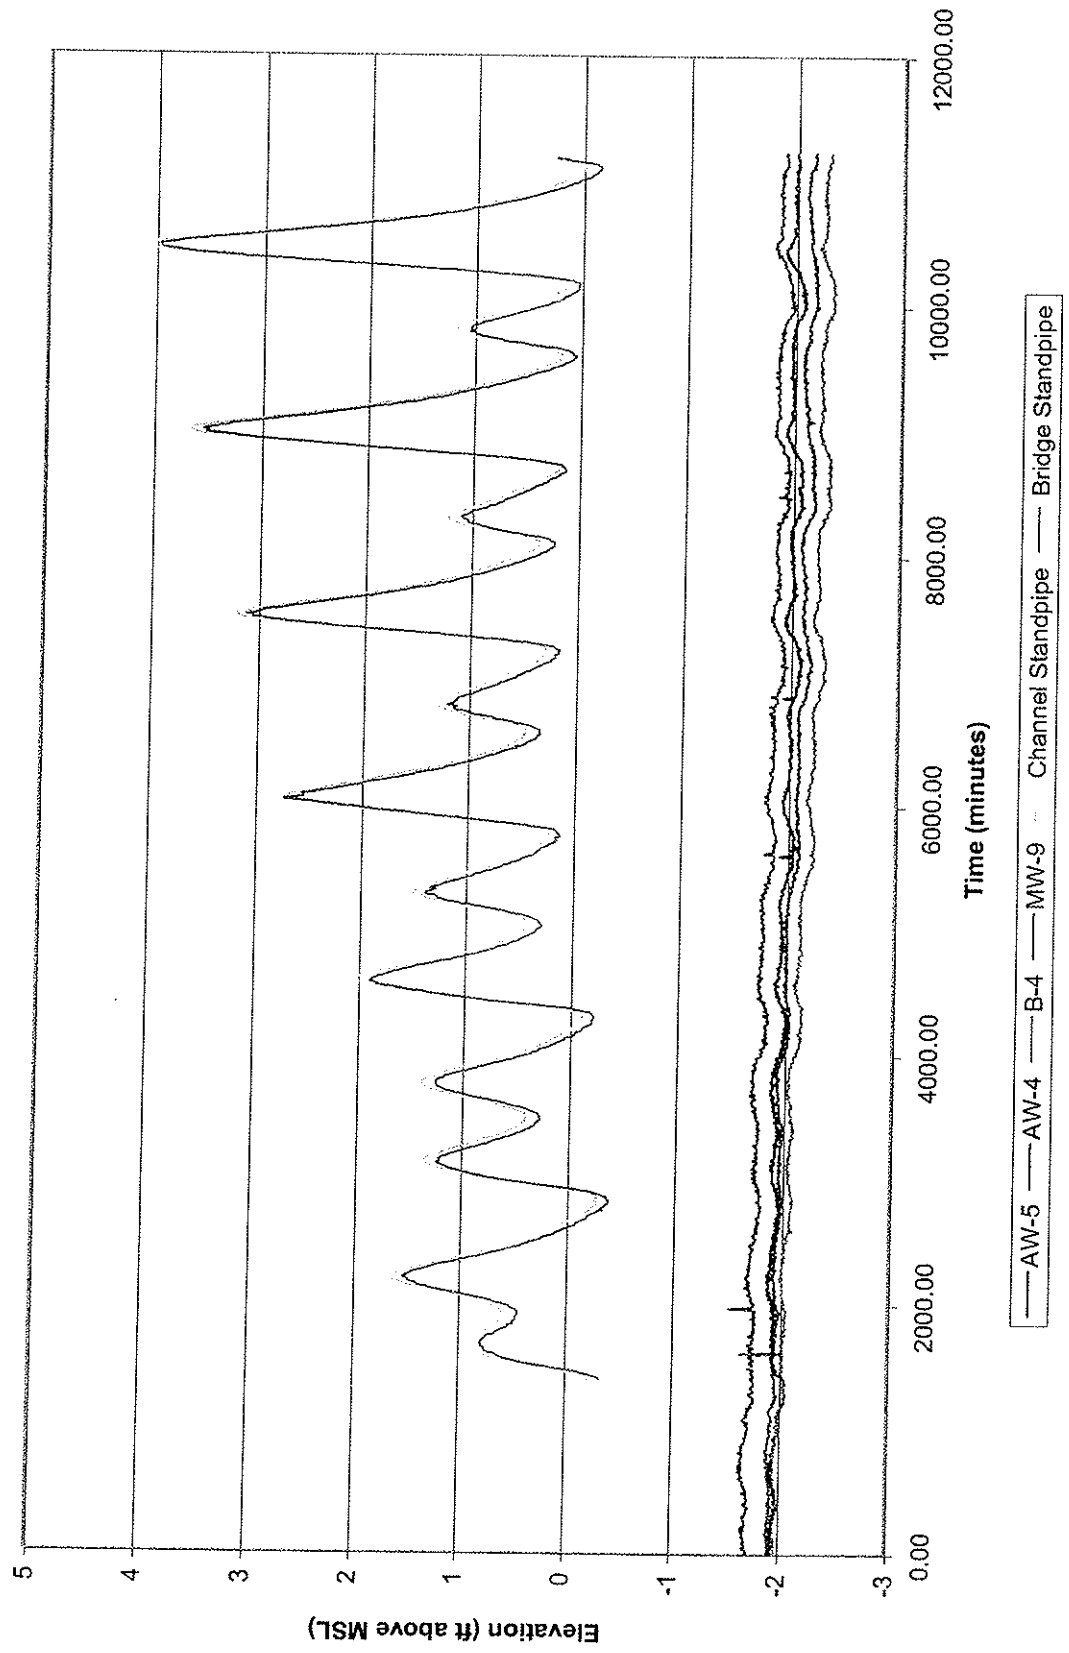
Figure 3 - Tidal Influence Investigation Water Elevation Data (6/5/03 14:40-6/13/03 9:50)

Both channel measuring points ("Channel Standpipe" and "Bridge Standpipe") showed approximately the same amount of water level fluctuation. The fluctuation was clearly in response to tides. The greatest fluctuation (>4 feet) occurred on June 12th and June 13th (near the end of the test) during a period when ocean tides at Balboa Pier in Newport Beach showed an approximate 6 feet of difference from high to low tide. This indicates that water level fluctuation in the channel is muted somewhat compared to fluctuation in the ocean, as would be expected in a restricted channel inland of the beach. Nevertheless, water levels in the channel are clearly influenced by tides.

As shown on Figure 3, groundwater levels fluctuated during the test. Groundwater levels in all four wells responded in a similar manner throughout the monitoring period. Close inspection of the data indicate both a general decline of water levels in all wells over the monitoring period, as well as short-term fluctuations on the order of ½ to 1 day in duration with a magnitude of less than 0.2 foot. The data do not indicate a clear relationship between the observed short-term groundwater fluctuations and the tidally influenced water levels in the channel. Instead, the groundwater fluctuations coincide more closely with changes in barometric pressure that occurred over the monitoring period. Even if some of this fluctuation were caused by tidal influence, the magnitude of that influence is minimal (< 0.2 feet).

The water level fluctuations in the channel did not significantly affect the groundwater flow direction beneath the western portion of the site that is adjacent to the channel. As shown on Figure 3, the groundwater levels in all site wells responded in a similar manner throughout the monitoring period. Although the absolute elevation of groundwater changed during the monitoring period, the relative elevation did not change significantly. The groundwater flow direction as measured in the 4 wells remained relatively constant (north to northeast).

Data collected during the tidal study clearly indicate that site groundwater does not discharge into the channel. Groundwater elevations were approximately 1 to 2 feet lower than water levels in the channel throughout the monitoring period. This relationship indicates that "losing stream" conditions occurred in the channel, that is, the channel discharges to shallow groundwater.

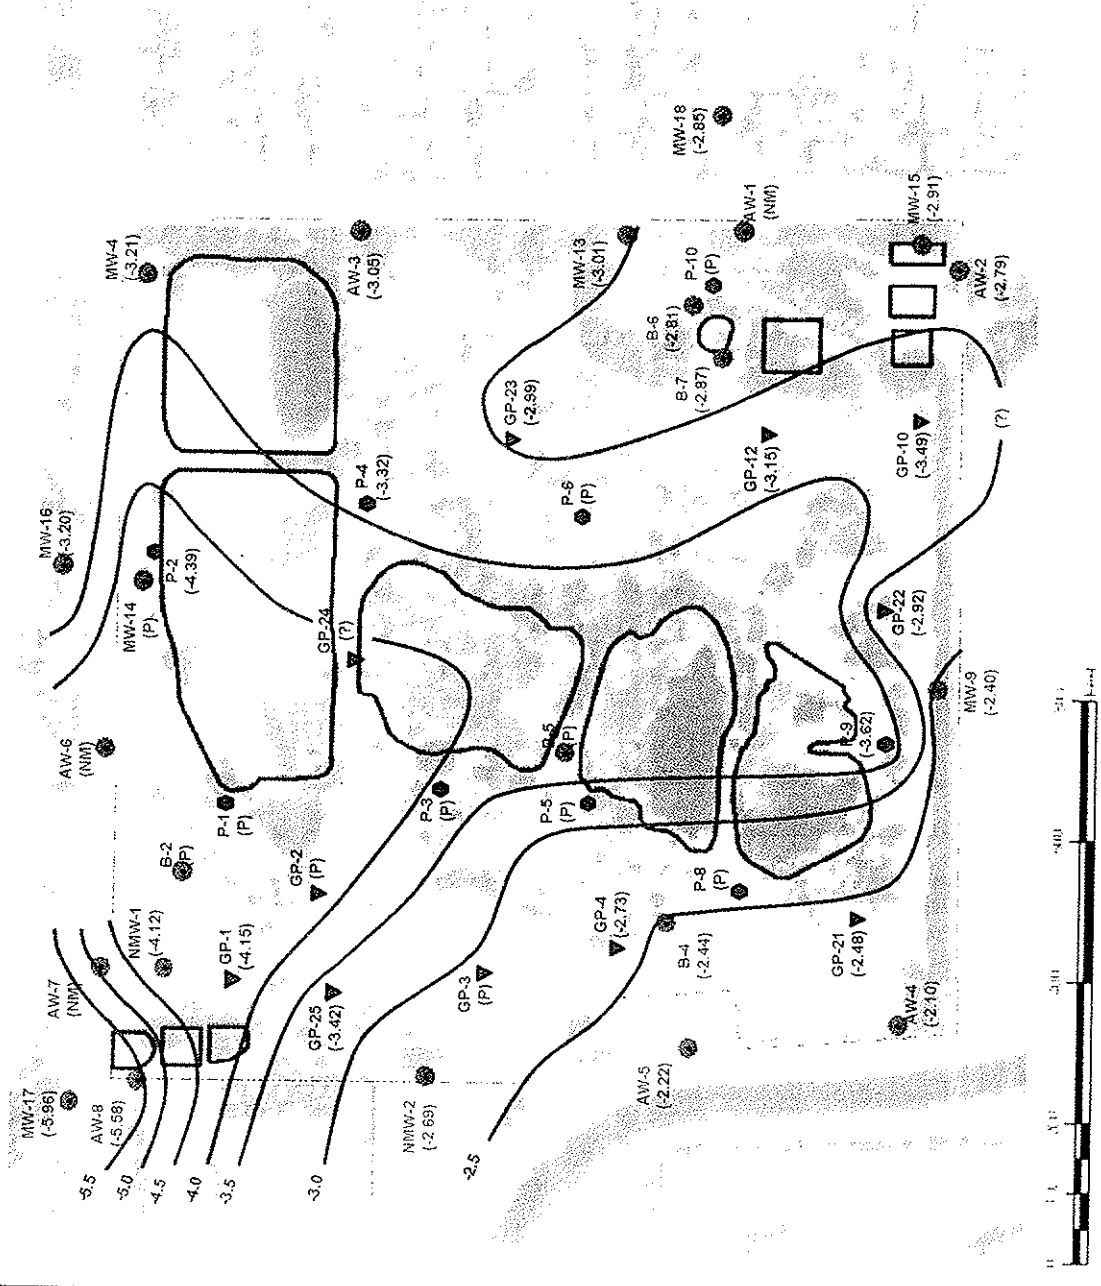
Semi-Perched Groundwater Contour Map—June 26, 2003

Groundwater elevation data were plotted onto a site map and contoured by hand. Only data from SPA wells/monitoring points that did not contain measurable product were contoured. This map is presented as Figure 4. It is significant to note that this is the first gauging event that includes all wells and monitoring points in a single gauging event. The data indicate a groundwater flow direction that is generally northerly; however, the data suggest a slight groundwater trough around the pond areas in the middle portion of the site. The June 2003 gradient is consistent with the previous gauging events and demonstrates that groundwater flow direction in the western portion of the site is away from the channel (generally to the north and northeast).
