Ascon Landfill Site
Emergency Action Completion Report

EMERGENCY ACTION COMPLETION REPORT

Ascon Landfill Site
Huntington Beach, California

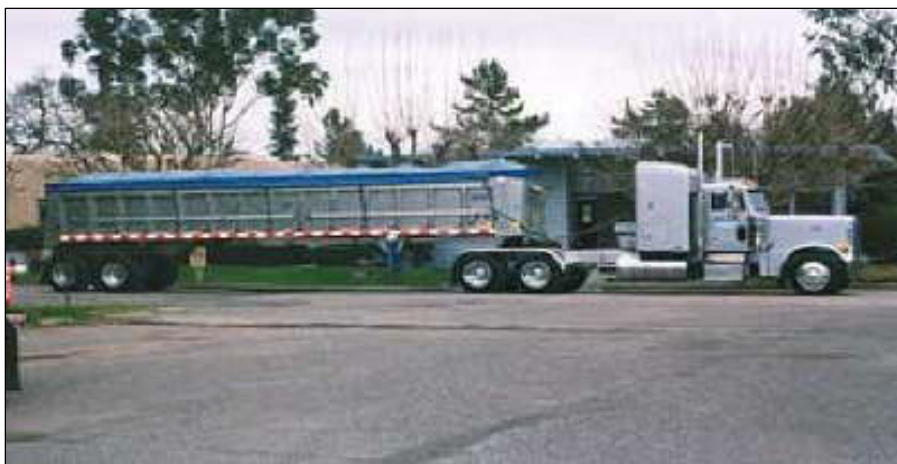
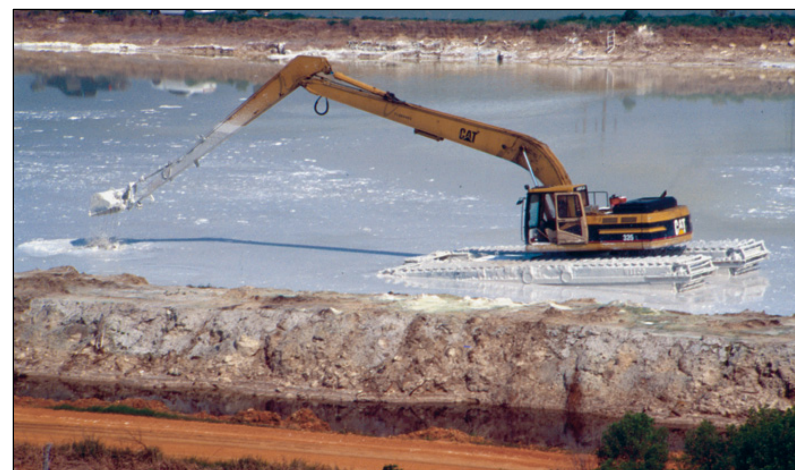
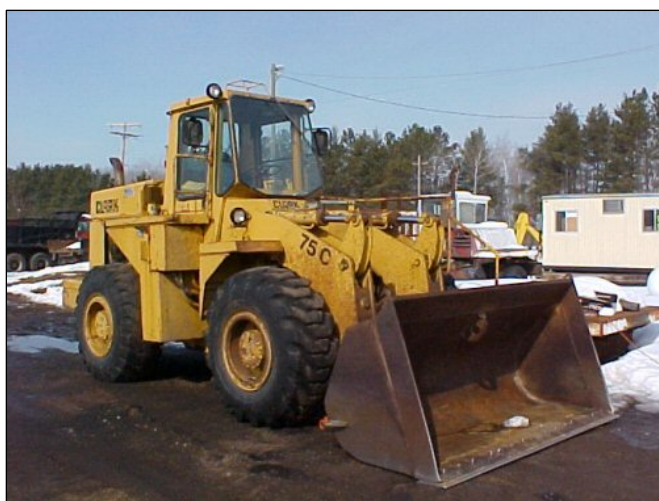
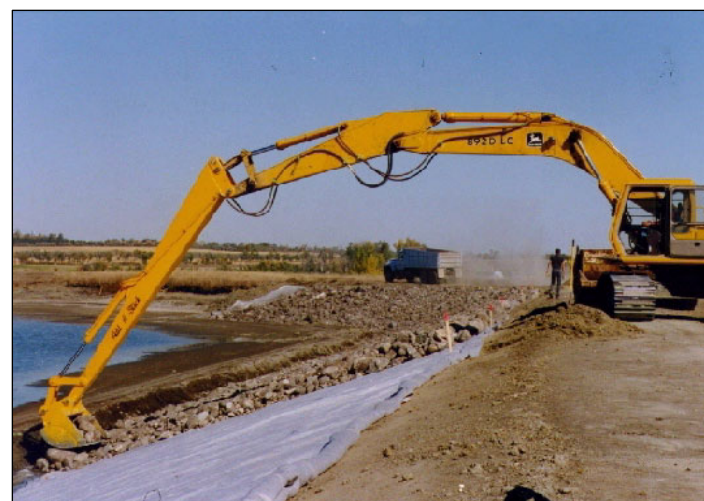
Tarped Truck

Pontoon-Mounted Excavator

Front End Loader

Long Reach Excavator

Emergency Action Equipment

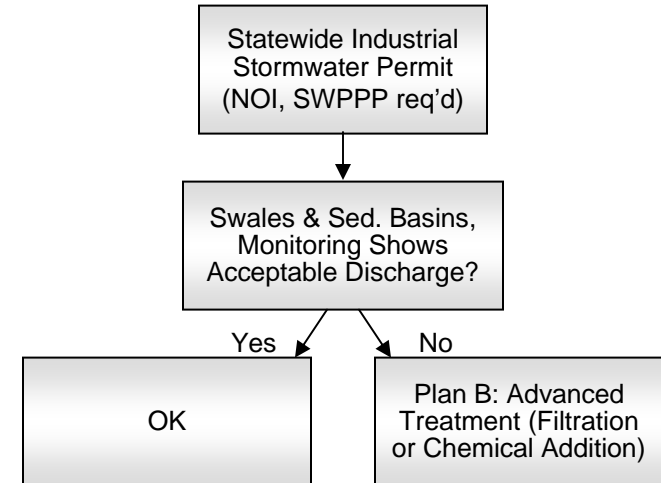
Figure 2.2-2

Contact Water

Non-Contact Water

Surface Water Management Strategies – Contact and Non-Contact Stormwater

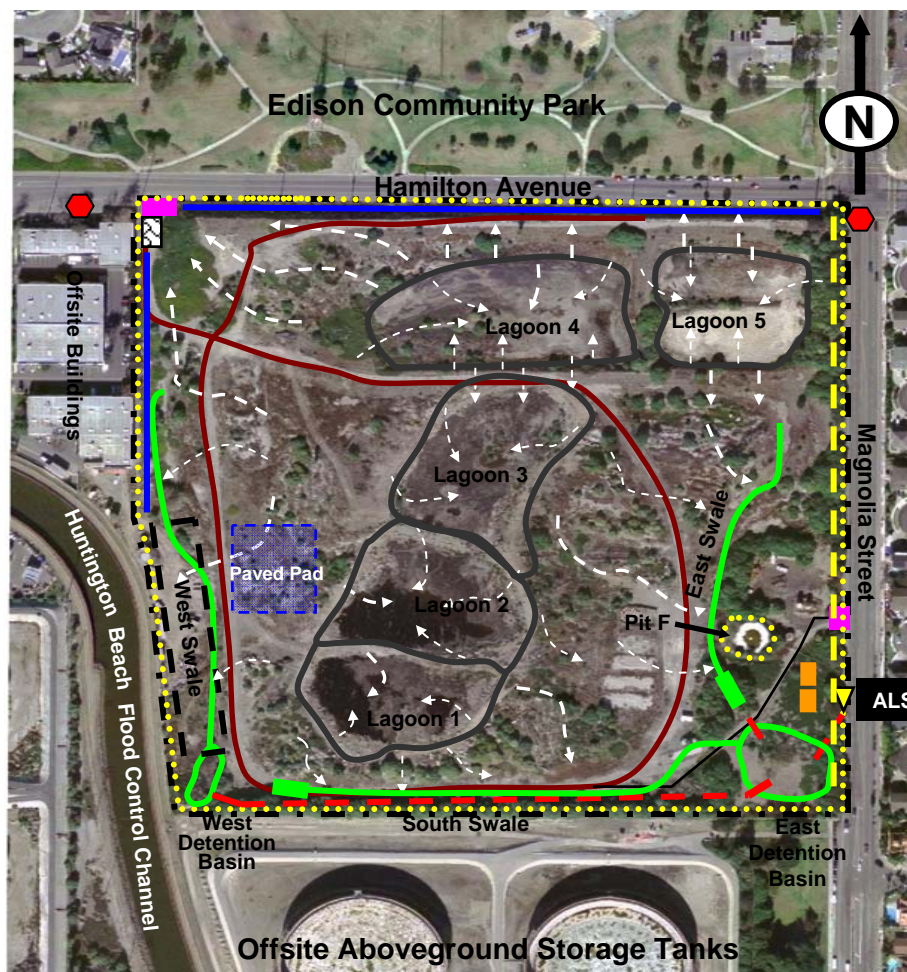
Figure 2.2-3

Industrial Stormwater Pollution Prevention Plan Site Map and Best Management Practices

The general onsite drainage direction is towards the lagoons for the areas immediately surrounding the lagoons, and towards the southeast for the non-lagoon areas, or approximately two-thirds of the Site. The only exception to this general drainage pattern is for the slopes on the northern and northwestern perimeter of the Site which drain north onto Hamilton Avenue and to the west. Both slopes also have toe drains which collect potential seepage water for pumpback into Lagoon 2 (see Section 2.1.4 and **Figure 2.2-3**).

Three grass swales are provided for conveyance and treatment of non-lagoon stormwater runoff, as shown in the attached Industrial SWPPP Site map (**Figure 2.2-3**). These facilities are used to treat runoff through a combination of vegetation and soil filtration. The swales are sized to treat 85 percent of the average annual runoff volume, consistent with the volume-based design criterion for the Site's detention basins and guidance from the WEF Urban Runoff Quality Management manual [URQM, 1998]. The swales are designed to accommodate a design rainfall intensity of 0.36 inches/hour based on the 0.74 inch depth, 2-hour duration rainfall event from the Orange County Hydrology Manual [OCHM, 1986] per the guidelines in the WEF Urban Runoff Quality Management manual. The dimensions of the swales were determined using Manning's Equation with a conservative manning coefficient of 0.24 corresponding to infrequently mowed swales. After the swales were sized to treat the design flow (i.e., design depth of 4 inches, or flows not to exceed grass height), each swale's total capacity was confirmed to accommodate the 50-year peak flow for flood control purposes.

Two dry extended detention basins have been designed and constructed for the purpose of reducing sediment and other pollutant loading in stormwater discharges from the non-lagoon areas of the Site as shown in **Figure 2.2-3**. The basins will promote sedimentation of suspended sediment and sediment-associated pollutants prior to discharge of stormwater from the Site. Target pollutants include sediment, metals, oil and grease, and other hydrophobic organics.
