Geologic Cross-Section Through Orange County Groundwater Basin

Map Source: PNL
Ascon Landfill Site
Huntington Beach, California

SITE CROSS-SECTION A-A'
ASCON LANDFILL

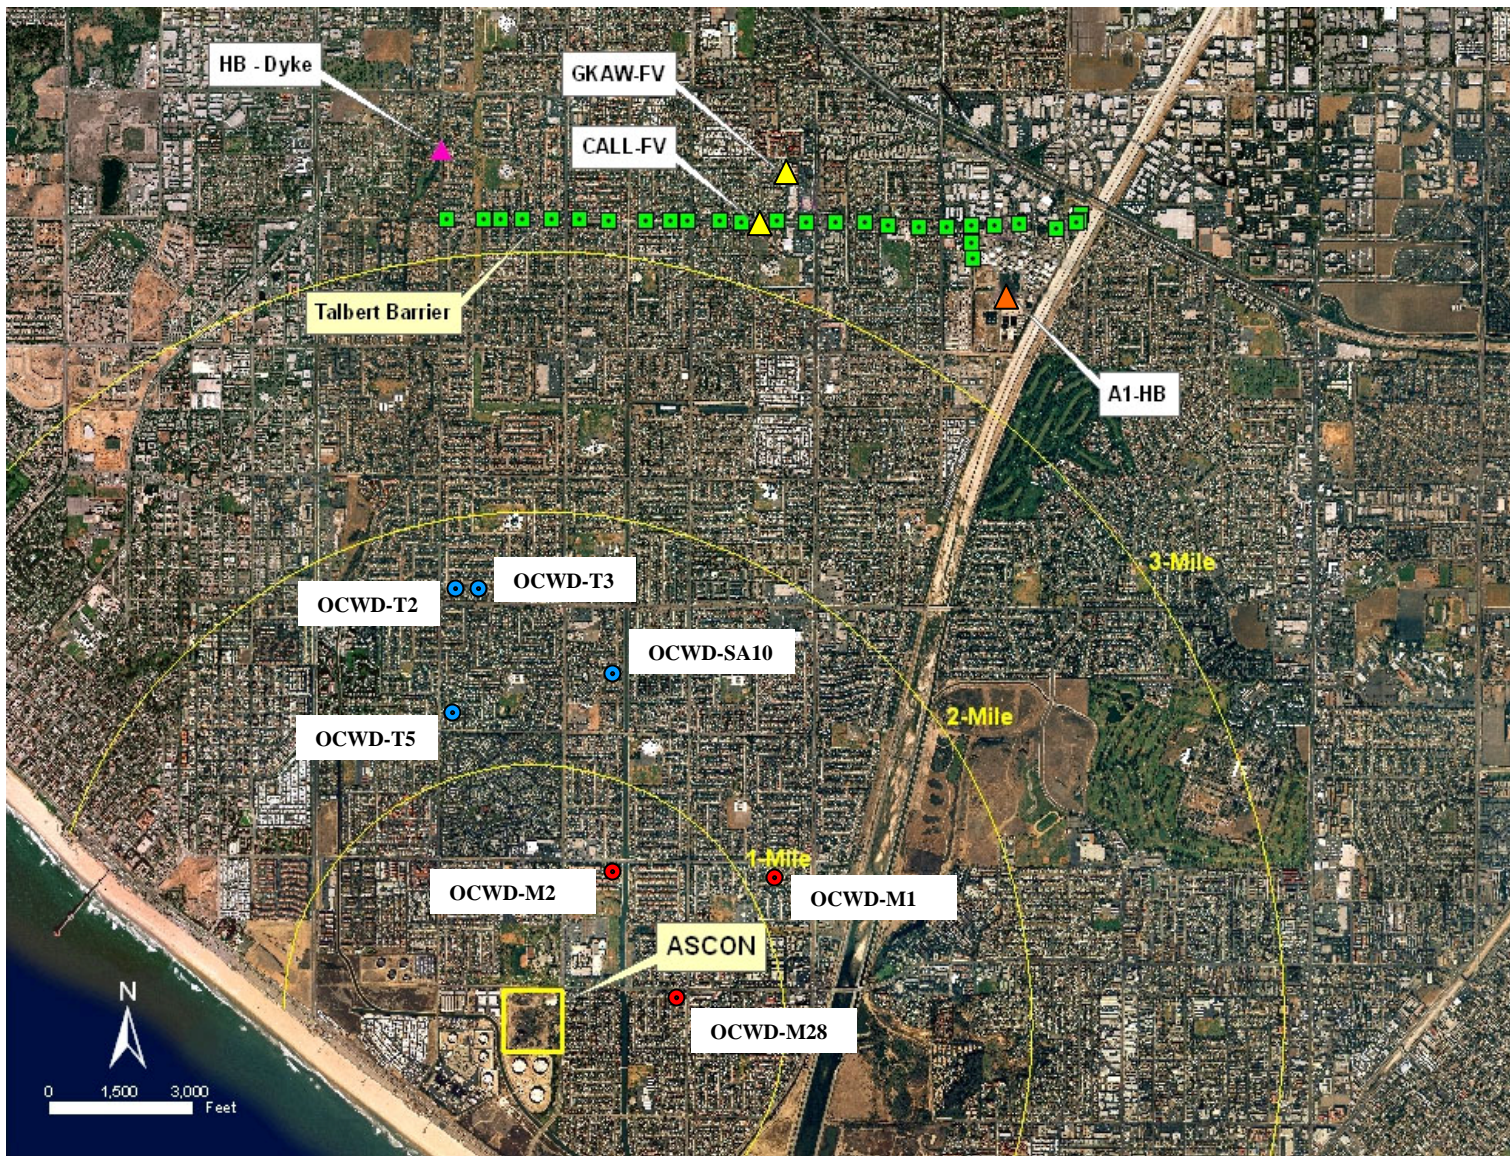
Distance to Drinking Water Wells and Selected Monitoring Wells in Talbert Gap Northwest of the Santa Ana River		Figure 5-3
Source: Orange County Water District – Personal Communication Ascon Landfill Site, Huntington Beach, California		March 2005

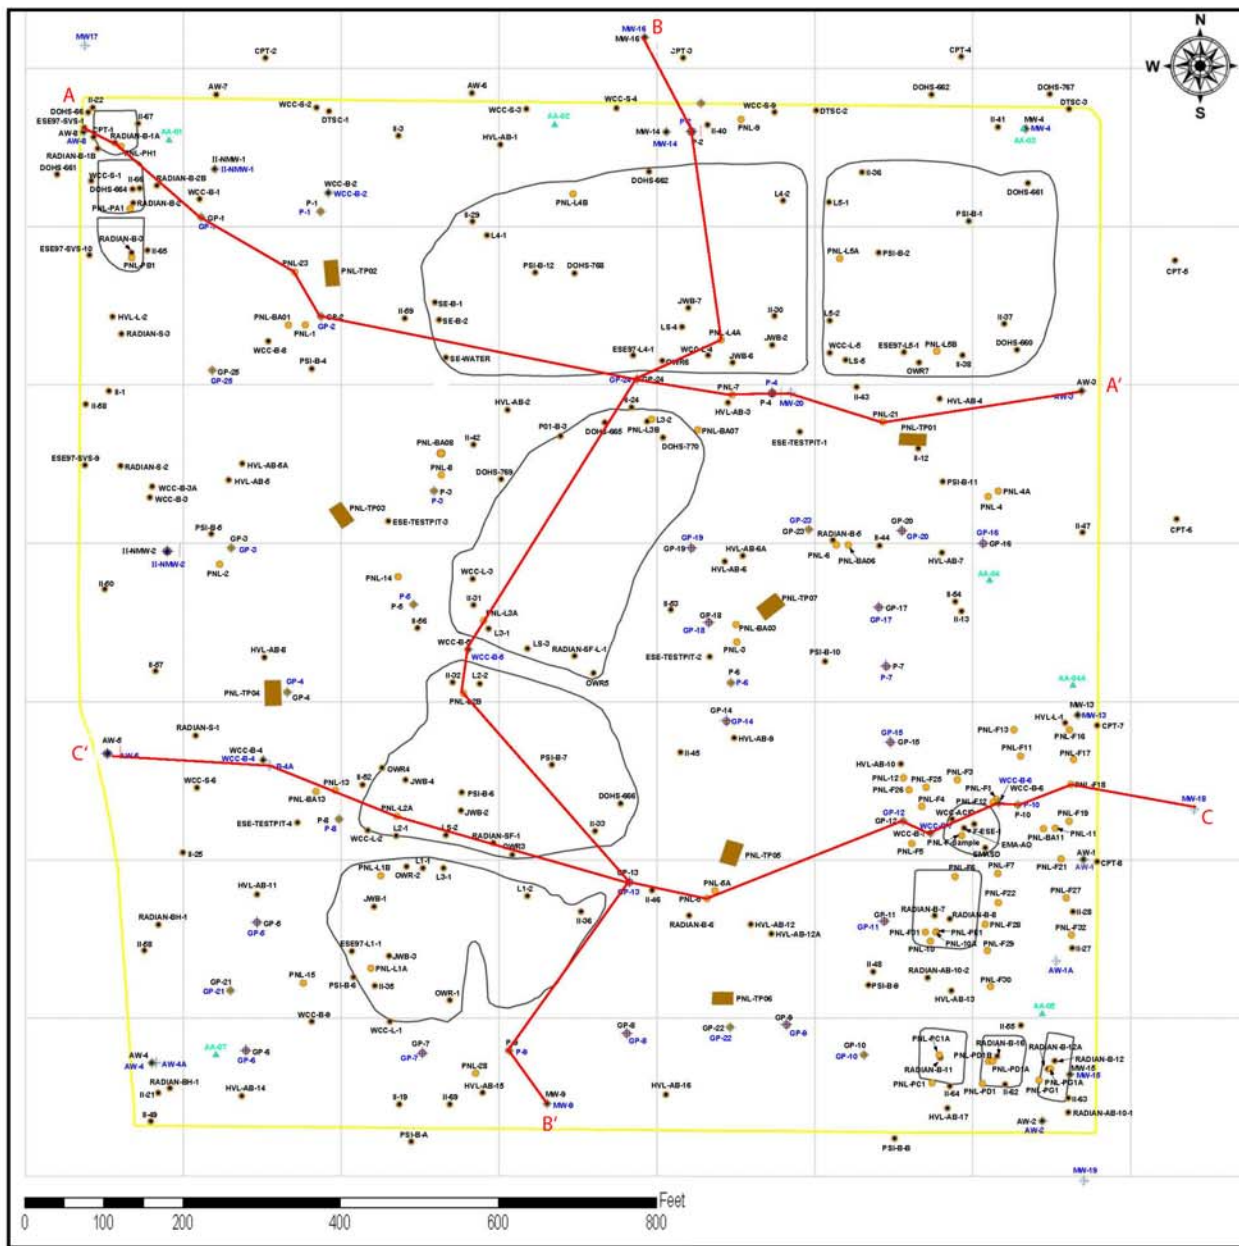
Figure 5-4

Groundwater monitoring points are labeled with additional blue text.

Cross- Section Lines A-A', B-B', and C-C'

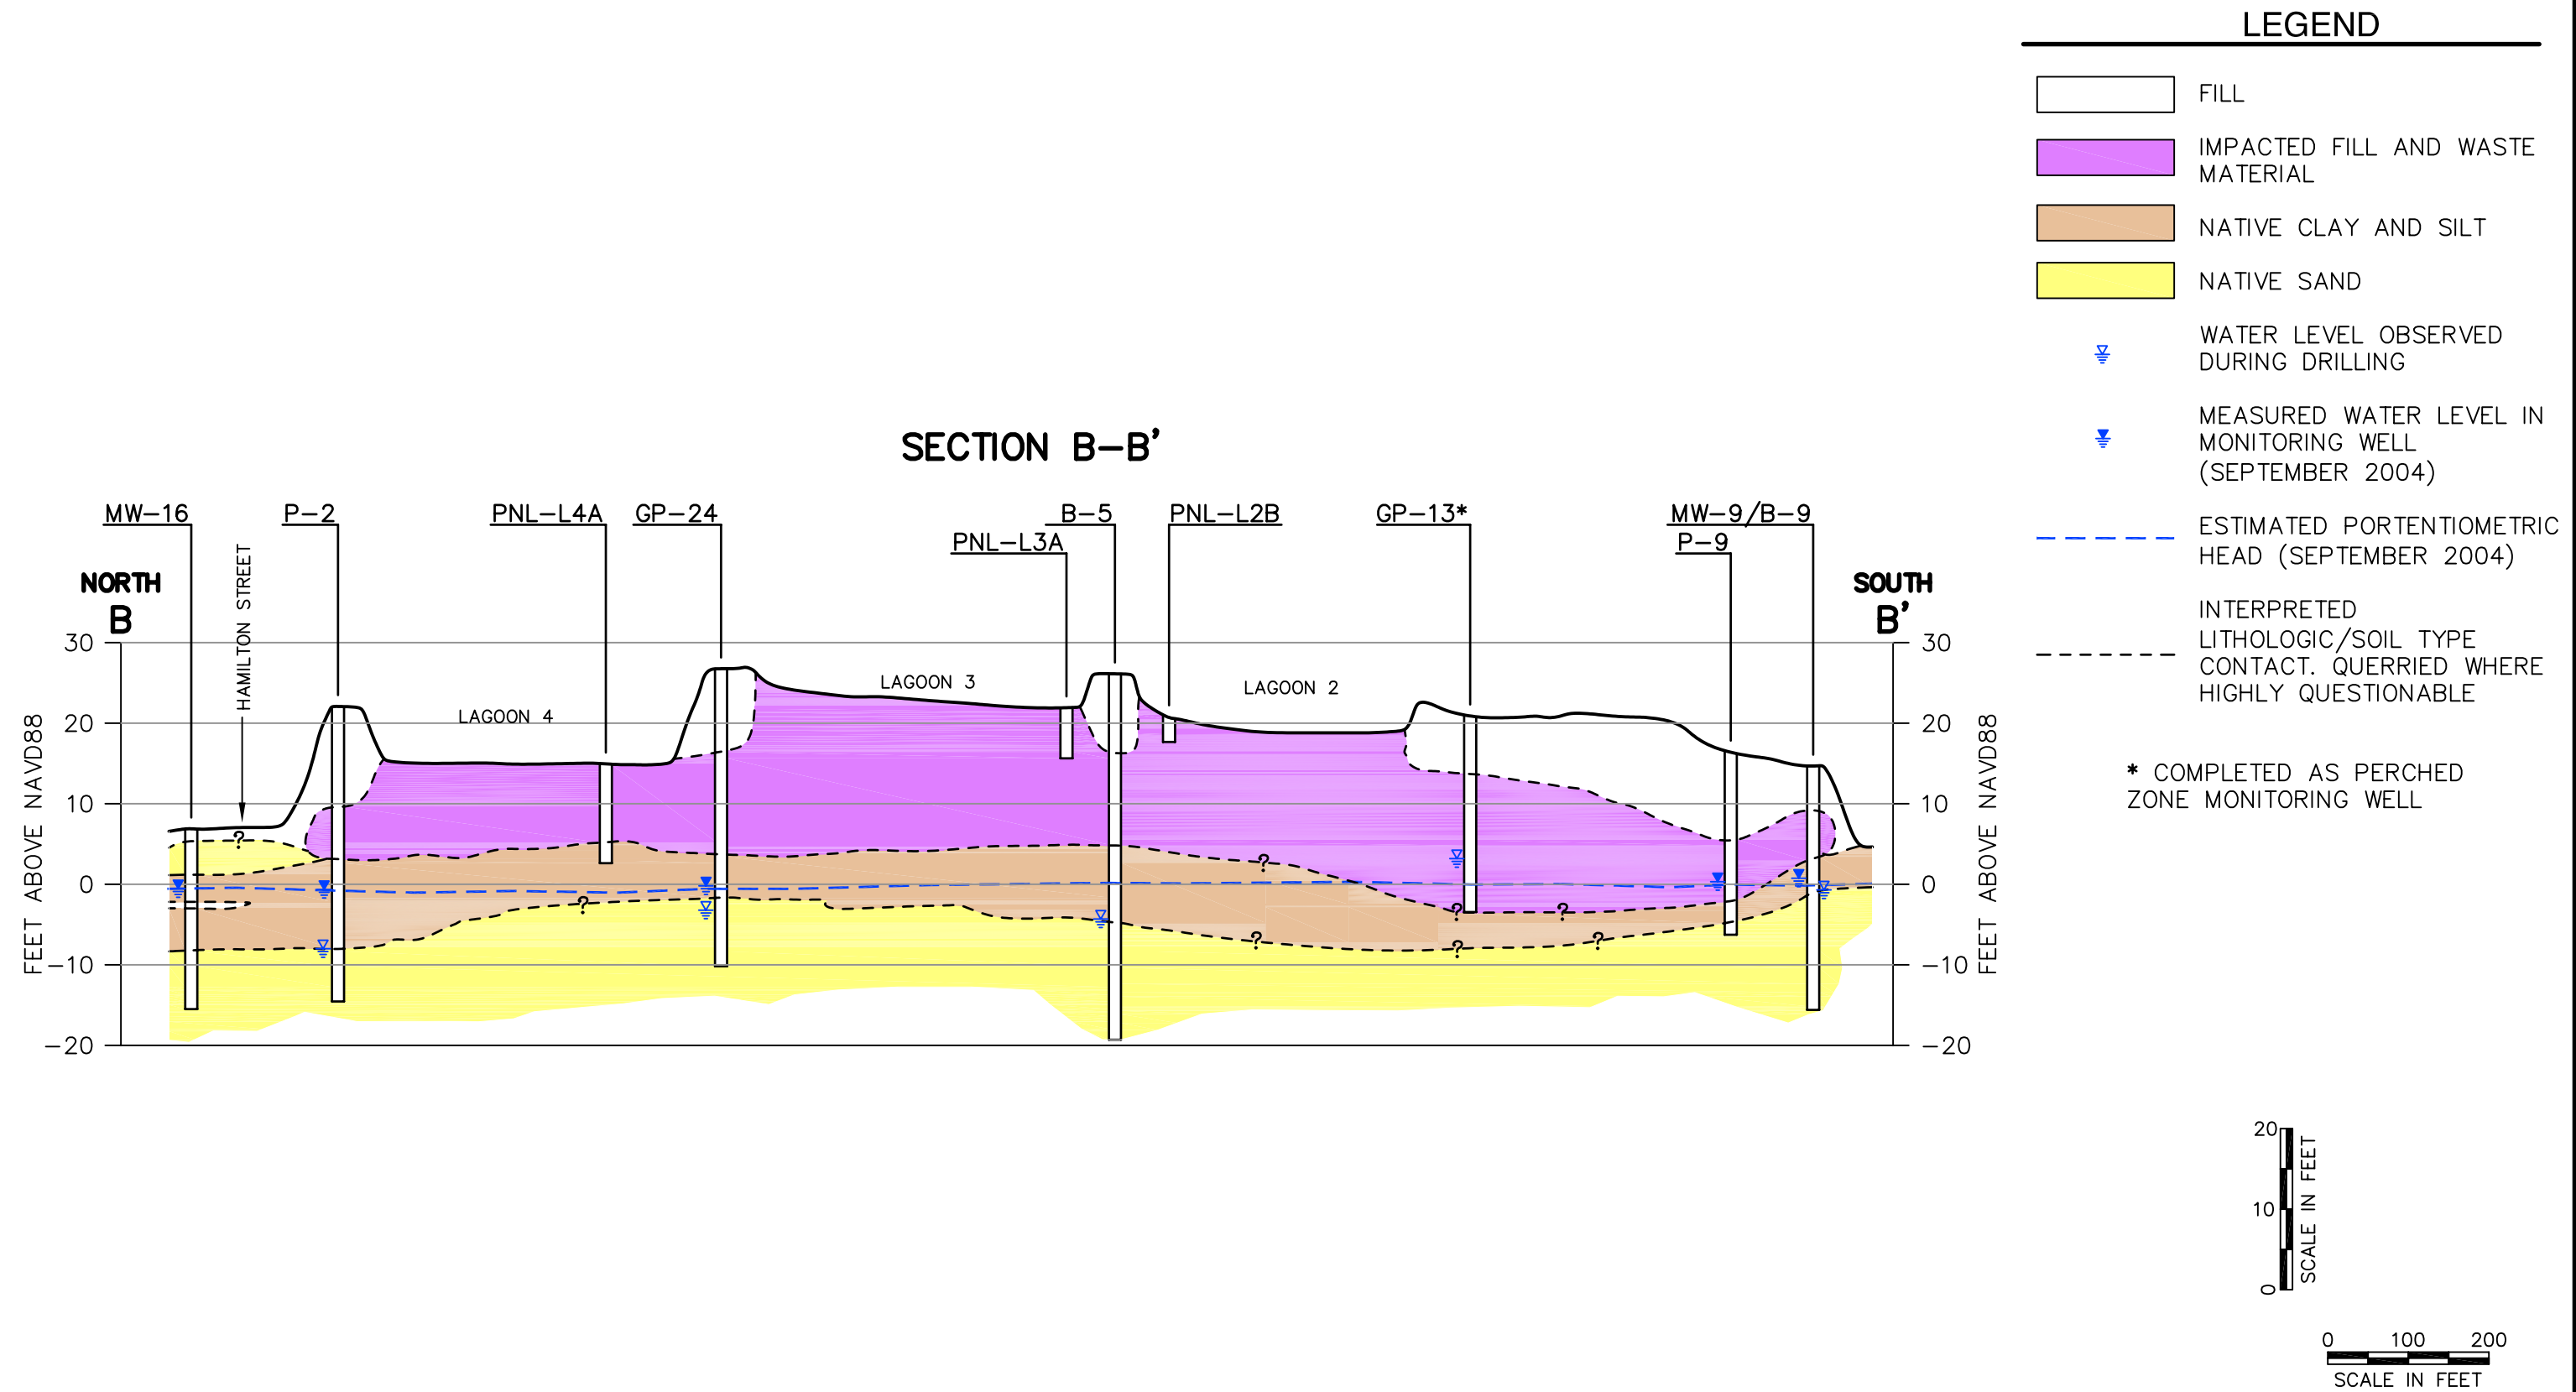
FIGURE NO.	5-6
PROJECT NO.	SB0202-25
DATE:	MARCH 2005

SITE CROSS-SECTION B-B'
ASCON LANDFILL

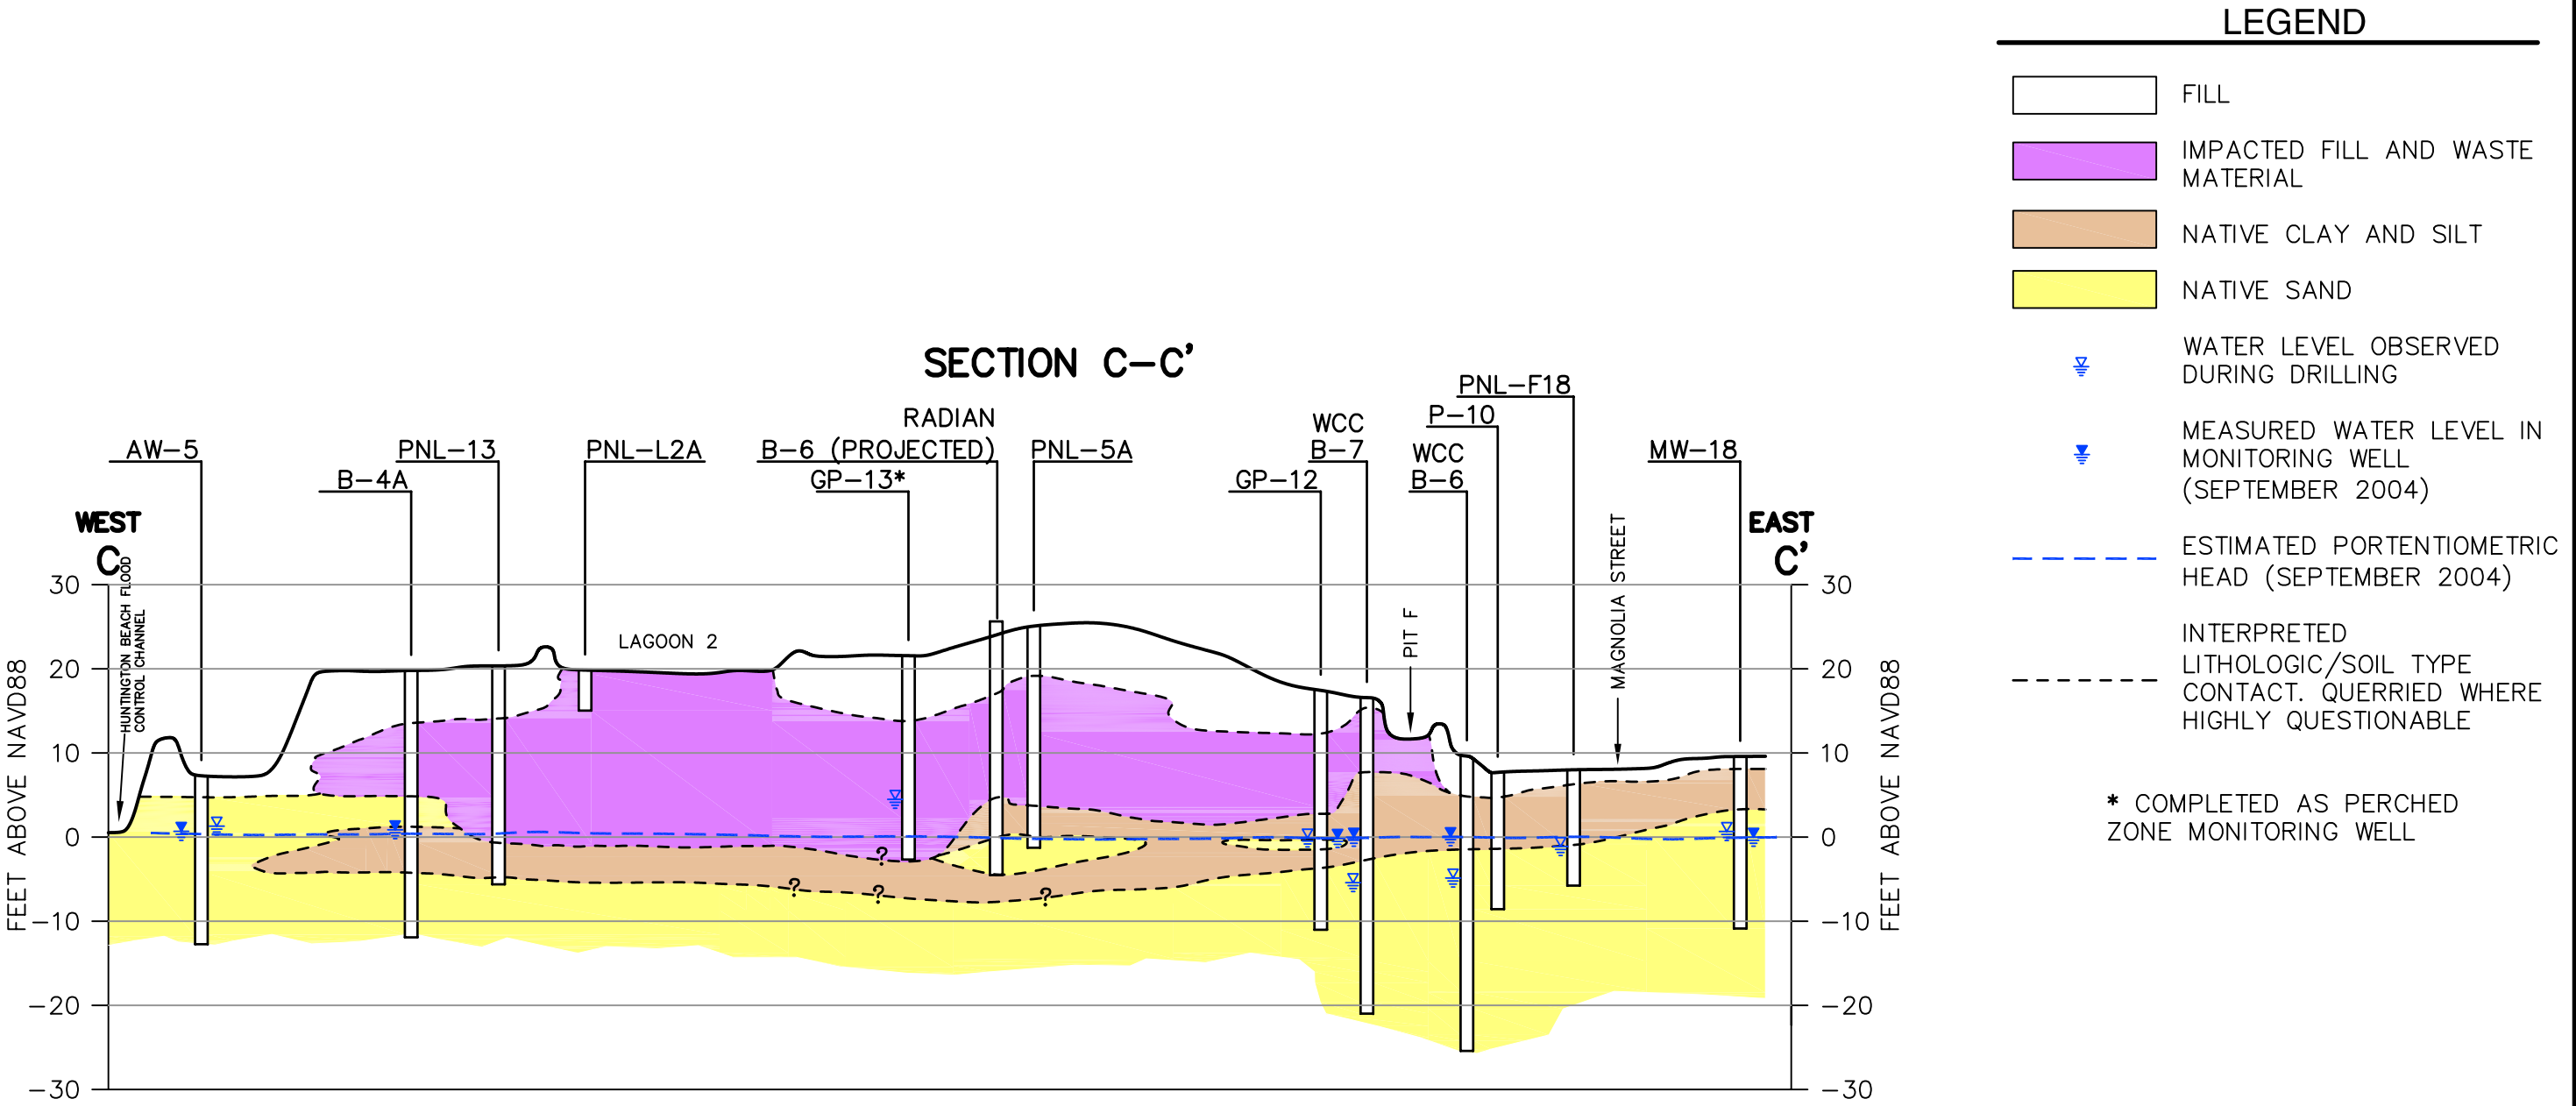
GEOSYNTEC CONSULTANTS	
SITE CROSS-SECTION C-C' ASCON LANDFILL	
FIGURE NO.	5-7
PROJECT NO.	SB0202-25
DATE:	MARCH 2005
